**"The Lodox full-body scan is an ideal imaging tool for evaluating patients with multiple injuries"**

### A case study from the Emergency and Trauma Centre, Rashid Hospital, Dubai.

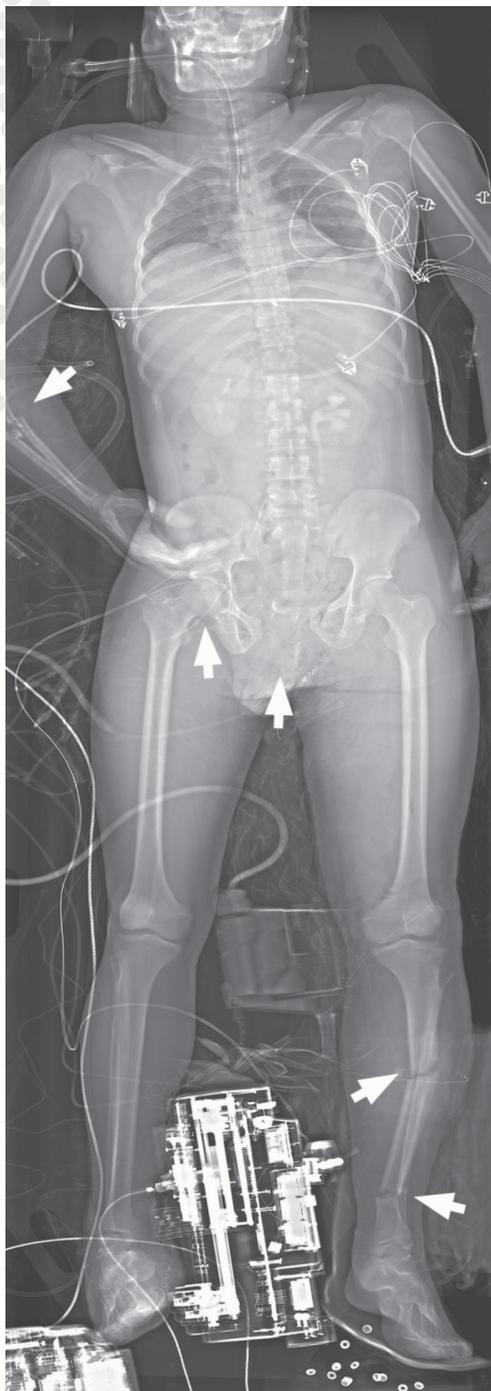
A trauma CT scan and Lodox full-body X-ray scan was performed. The Lodox images indicated fractures of the left tibia and fibula (middle and lower third), fractures of the proximal aspect of the right radius and ulna, fractures of the right acetabulum and the left inferior pubic ramus. Also, pubic symphysis diastasis was clearly indicated in the Lodox image. The patient was intubated due to the multiple injuries and transferred to the operation theatre for emergency fixation and wound debridement of right knee and left thigh. ORIF symphysis pubis, external fixator bridging of the left knee was also done on the same day along with vacuum sealing of the right foot. Further surgeries were performed including ORIF plating and K-wire of right radial styloid process once the patient was stable.
